THE CAUSES OF DAMAGES TO GAS TURBINES OF AVIATION TURBO-JET ENGINES

Milan Seman – Marián Hocko

The article provides an analysis of thermal deformations and damages to selected parts of aviation turbo-jet engines. The emphasis is laid upon damages to blades through corrosion, gas erosion, material cutting as well as cracks and fractures resulting from the operation of given types of aviation engines.

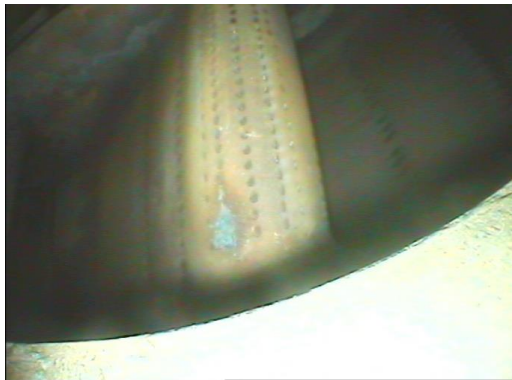
Fig. 4 Gas corrosion on the guiding mechanism of the high-pressure gas turbine (photo Martin Schmidt)

Fig. 4 shows the visible areas of advanced stage of corrosion, when fall out (scale off) of the corroded layer occurred. The illustration also shows the proximity of the damaged area becoming apparent through visible changes in the colour, proving local loss of resistance within the surface area.

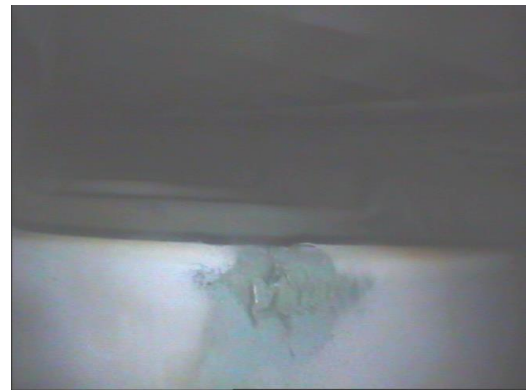
Fig. 5 Material cutting (burn-out) of material on the guide-vanes in the guiding duct of the low pressure turbine of the RD-33 engine (photo Martin Schmidt)

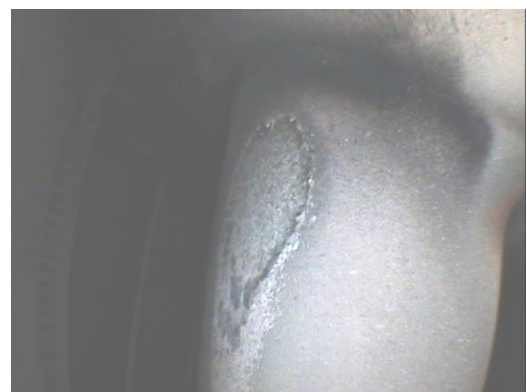
Fig. 6 Material cutting (burn-out) on the guide vanes in the guiding duct of the low pressure gas turbine of the RD-33 engine (photo Martin Schmidt)

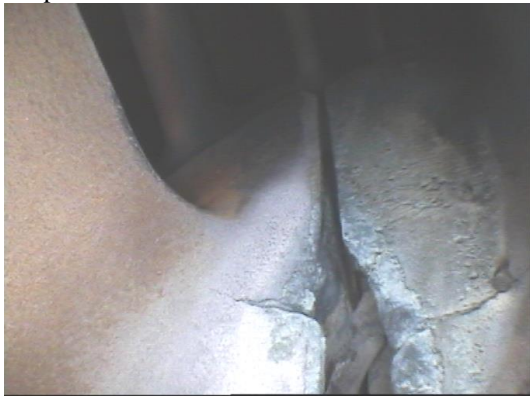
Fig.7 Material cutting (burn-out) in the area of contact with the sectors of guiding vanes (photo Martin Schmidt)

Fig. 7 is an evidence document on cutting (burn-out) along the line connecting guide vanes sectors in the rear part resulting from crack development.

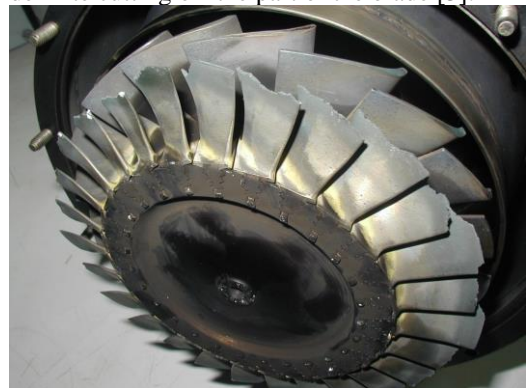
Fig. 8 Destroyed rotor blades of the gas turbine on the MPM-20 experimental jet-engine as a result of thermal and mechanical damage (photo Marián Hocko)

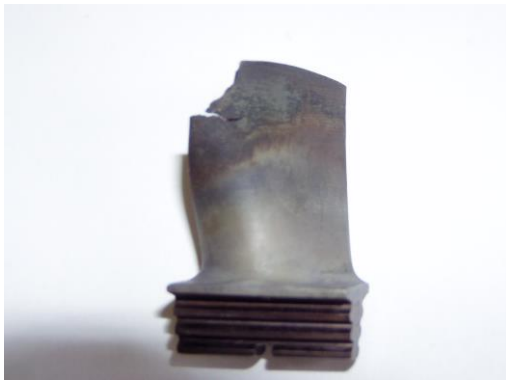
Fig. 9 Detail of the destroyed rotor blade, part of the MPM-20 experimental jet engine as a result of thermal and mechanical damage (photo Marián Hocko)

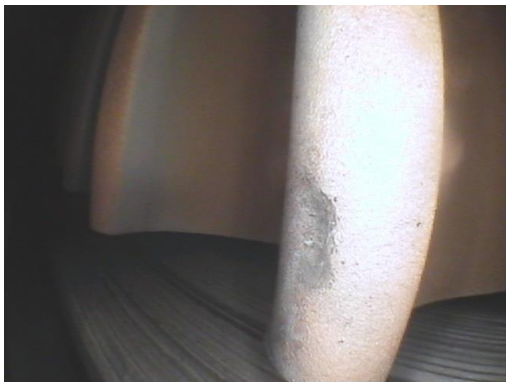
Fig. 10 is a recording of the remarkable callus on the surface of the HP gas turbine blade, part of the RD-33 engine with changes in the profile shape (impression in depth). The callus is located on the end part where the

leading edge is transitioning into the back of the rotor blade.

Fig. 10 Deformation on the surface of the rotor blade leading edge of the high pressure gas turbine (photo Martin Schmidt)

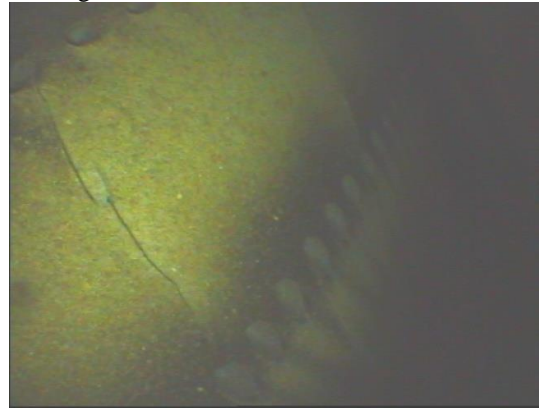
Fig. 11 Cracks on the guiding vane of the high pressure gas turbine (photo Martin Schmidt)

Fig. 11 is an evidence of cracks that have developed in the leading edge area and are propagated along the profile in the bed-side of the high pressure gas turbine guiding vane.

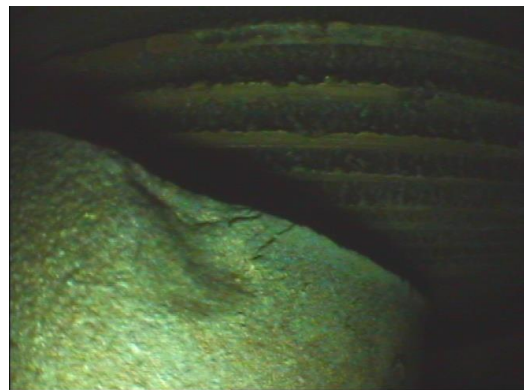
Fig. 12 Crack and collapse of the rotor blade on the high pressure gas turbine of the RD-33 engine (photo Martin Schmidt)

Fig.12 is an evidence of a crack at the end of a blade and also of the apparent traces of blade profile collapse in the weakened area.

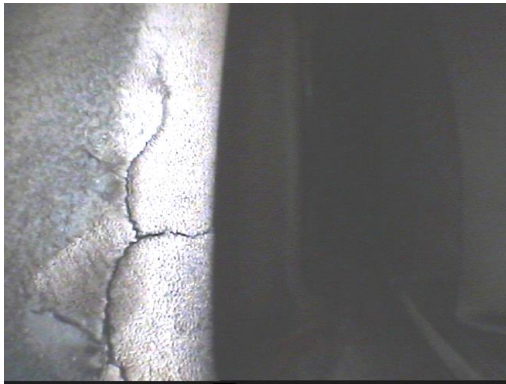
Fig. 13 Branched crack on the guide vane of the low pressure gas turbine on the RD-33 engine (photo Martin Schmidt)

Fig. 13 is a branched crack in the leading edge area of the guide vane on the low pressure gas turbine of the RD-33 engine. Probably, it is a crack in the surface layer.

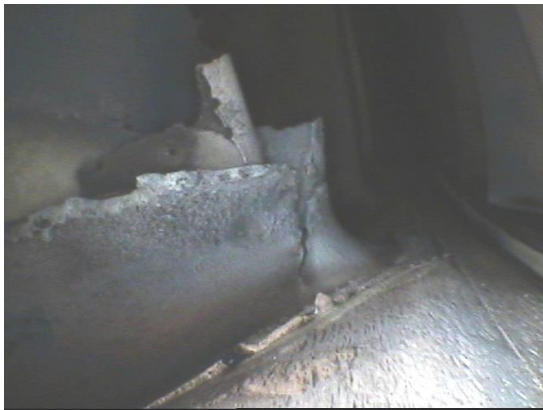
Fig. 14 Fractured guide vane of the low pressure gas turbine on the RD-33 engine (photo Martin Schmidt)

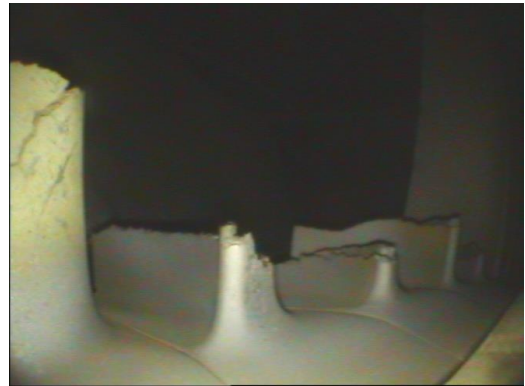
Fig. 15 Broken rotor blades of the low pressure gas turbine on the RD-33 engine (foto Martin Schmidt)

Fig. 15 is documenting five broken rotor blades located side-by-side in a row on the low pressure gas turbine of the RD-33 engine. Fractured blades were located also on other parts of the blade grid of the low pressure turbine. Viewing the picture, one cannot unambiguously determine whether it is the result of mechanical damage of running blades, as the fracture on these rotor blades could also have resulted from the loss of fire-resisting characteristics followed by the destruction. Only the next photo in Fig. 16 can unambiguously prove mechanical damages on the rotor blades of the gas turbine. Fig. 16 is an evidence of mechanical damages on the leading edge at the ends of the rotor blades on the LP gas turbine of the RD-33 engine.

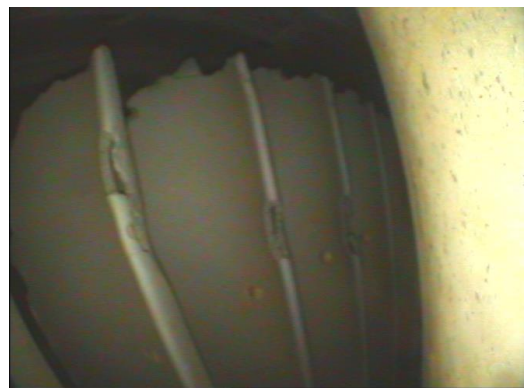
Fig. 16 Mechanically damaged rotor blades on the low pressure gas turbine of the RD-33 engine (photo Martin Schmidt)

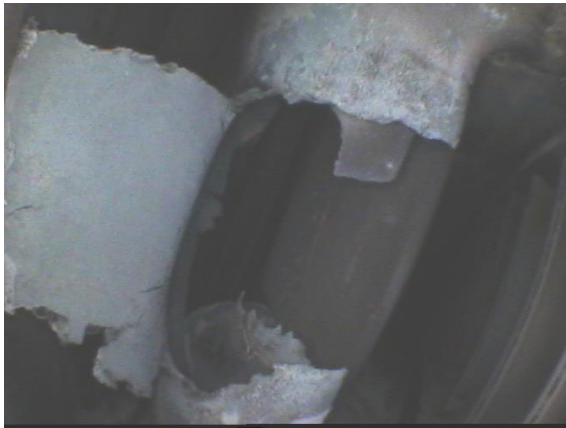
Fig. 17 is illustrating a further case of destructive damages hollow guide vanes on the LP gas turbine of the aviation engine. It is the case when the development of cracks results damages to the material and subsequently opening up the guide vanes of the gas turbine. Quite frequently, a whole set of guide vanes of the gas turbine stage is torn open.

Fig. 17 An open guide vane of the low pressure gas turbine on the RD-33 engine (photo Martin Schmidt)
