## EXPERIMENTAL STUDY ON RADIAL COMPRESSOR INSTABILITY CAUSED BY INLET AIRFLOW RESTRICTION

Marián HOCKO, Maroš DIVOK, Maksym PETRENKO

Technical University of Kosice Faculty of Aeronautics, Rampova 1731/7, 040 01 Kosice, Slovakia

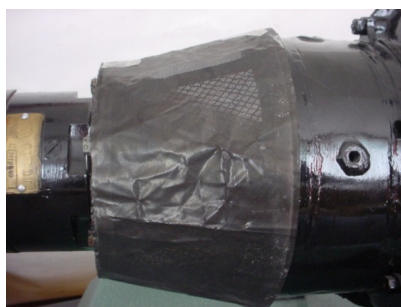
Figure 11 TV screen on the MPM-20 intake system

To assess the impact of extreme inlet restriction, a perforated sheet with 0.4 mm mesh, initially a TV screen shield, was placed over the engine's inlet. This change caused an 83% drop in effective inlet flow area.

Significant changes occurred in performance parameters during final tests. Pressure at station 2c dropped by 48,978.8 Pa, increased at station 3 by 24,198.5 Pa, and decreased at station 4 by 24,957.82 Pa.

Temperatures declined: station 2c by 11.6 K, station 3c by 92.4 K, and station 4c by 177.5 K. Fuel consumption decreased by 4.3465 kg/h. Pressure ratios changed: total compressor ratio ( $\Delta\pi_{Tc}$ ) increased by 0.6,  $\Delta\pi_{Kc}$  decreased by 0.509, and  $\Delta\pi_{VD}$  declined by 0.257.

Extended operation revealed engine instability: unstable radial compressor, damaged turbine blades, as seen in the Figure 12, and burned sealant, Figure 13 and 14. 83% inlet shading restricted airflow, reduced performance, and ultimately caused engine failure, showing that inlet restrictions beyond a threshold damage both performance and machinery.
