USING METHODS OF THERMOVISION IN AERONAUTICAL MAINTENANCE

Miroslav Čop – František Adamčík – Peter Mrva

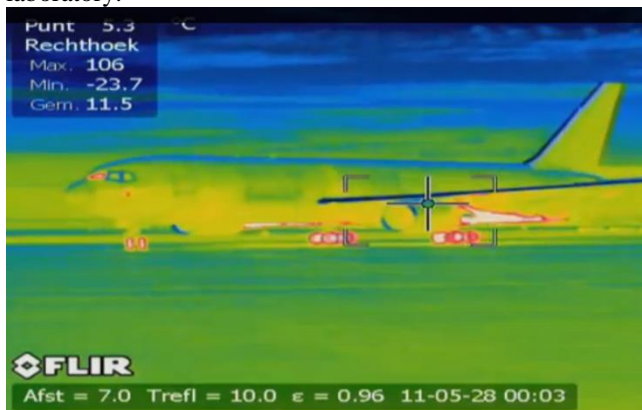
Fig. 2 Scanning at an aircraft taxiing down the runway

It is widely thermograph has taken off in the maintenance of aircraft. Aircraft are devices consisting largely of components characterized by different working temperatures. An incorrect way of working of individual parts, or upon the occurrence of degradation in them, their working temperature change. This way you can monitor the status of individual components and evaluate it on satisfactory or unsatisfactory. Inspections are normally performed in a short time immediately after the aircraft has landed and taxiing down the runway. Then the airframe accumulated thermal energy created rapid movement of aircraft in the atmosphere. It usually consists of stop faces, such as learning-wing area, the front of the fuselage, tail surfaces clamming surface and below. Checks are also temperature program after landing, but even the possibility that the exhaust gases from the engine in any way affect the thermal environment of the engine. Thermal imaging is also used in motor control, whether on an airplane or in a laboratory.

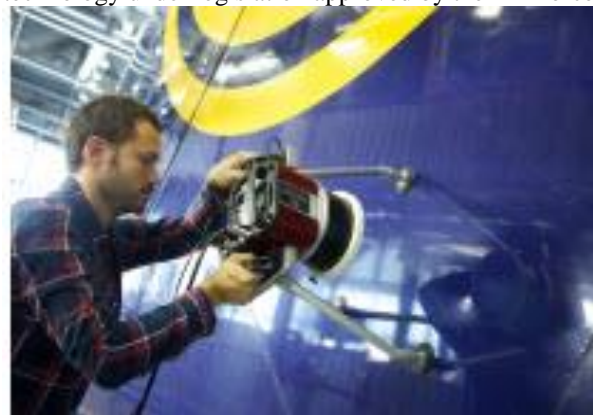
Fig. 3 Implementation of measuring the fuselage

IRT method has long been applied for studying surfaces of airplanes made of metal but for composite materials, the methodology differs. The use of this technology for composite materials is difficult because of the more complex structure of the material. Until recently the results are effective and safe way for complete and reliable assessment of the degradation of the materials. Measuring progress pulsed thermograph, where the surface slightly Heat the heat source (e.g. halogen bulb) and then we measure the surface temperature. The failure to spot heat does not spread consistently for the in homogeneity and consequently has a different temperature value. Active thermograph offers many advantages. One of them is the ability to capture a relatively large amount of space (0.25 to 0.5 square meters) at the same time. Another advantage is its use in the workshops, but also directly to the fuselage using mobile units.

The method works only in 4 mm thick, which allows considering about 80% of the airframe Boeing 787. For routine use in aviation technology is needed reliability methods and certification in practice, thus this technology under legislation approved by the Air Force.

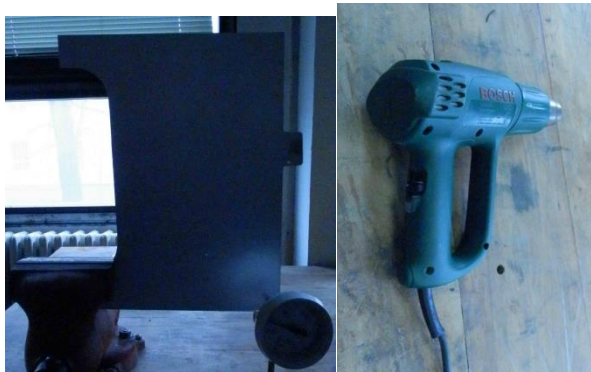
Fig. 4 Secured measured object and used hot air gun

Simulated the case where part of a wing was blowing hot air stream. Material of the cover is made wings are often used in aviation, and it is called aluminium alloy (Al-Mg-CU4). Even though the vast majority of aluminium itself is up to 95%, only 4% copper and magnesium less than 1%, the alloy as alloy much better features. Stream of hot air has been simulated with the help of hot air. Gun brand Bosch PHG 500-2 1600W power and has two levels of heat output temperatures of 300 and 500 ° C.

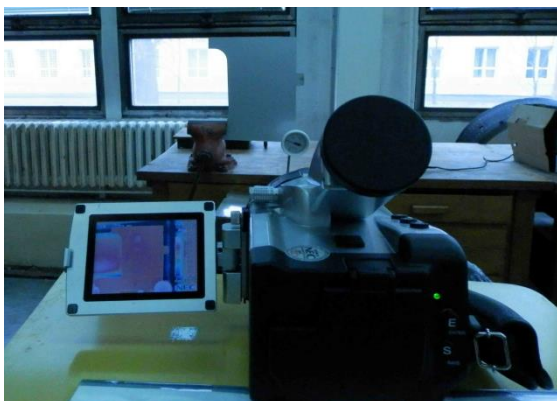
Fig. 5 Position of the thermal imager NEC at measuring

Duralumin plate was stationary because of the location and impact of high temperatures clamped in a vice. Subsequently, a heat gun plate placed at a distance of 70mm. On the other hand, measured perpendicular to the plate was placed infrared camera NEC TH9100WB with a resolution of 320x240 pixels. Thermal provides several measurement ranges. Two of them were used to measure at the lower initial temperature range -40 ° C to 120 ° C. This level was insufficient for higher temperatures, and was changed from 0 ° C to 500 ° C.

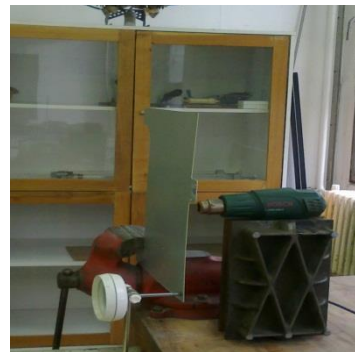
Measure number 1.

Fig. 6 Heating process at the first measurement

The first measurement has been made after fulfilling all the necessary requirements. The first shot was at zero time, at the time when he was starting his own plate temperature. Turning hot air temperature at the first stage (indicated by the manufacturer 300 ° C) were also running stopwatch. The first measurement was made out 12 images, each one minute intervals. The evaluation consisted of selecting the two different selected points from the heat, to which the hot air is blown directly. The largest increase in temperature, as expected, occurred in the first minute, and then increases the temperature in the intervals longer until sometime flat. After 12 minutes, the heat gun to detect low-paid and how the process of cooling for the duralumin plate.
