THE CAUSES OF DAMAGES TO GAS TURBINES OF AVIATION TURBO-JET ENGINES

Milan Seman – Marián Hocko

The article provides an analysis of thermal deformations and damages to selected parts of aviation turbo-jet engines. The emphasis is laid upon damages to blades through corrosion, gas erosion, material cutting as well as cracks and fractures resulting from the operation of given types of aviation engines.

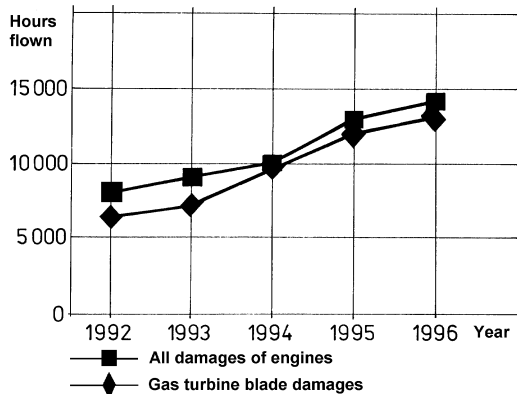
Fig.1. Comparison of average hours flown at CF6-80C2 engines disassembled owing to blade damages of gas turbine and further flaws as well

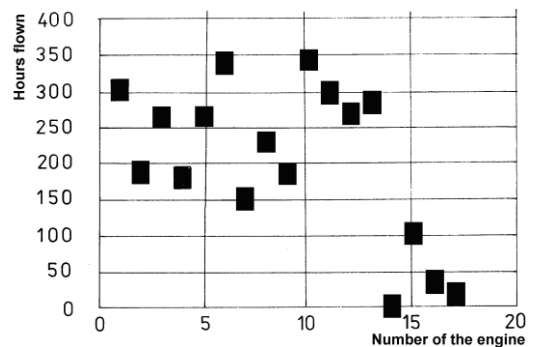
Fig. 2 Comparison of hours flown of RD-33 engines until GT blade failures occurred hours flown order of the engine

With the Slovak Air Force, on the MiG-29 fighters powered by RD-33 bypass engines, 33% as much as 42% of total engine failures have occurred due to damages of gas turbine components. The statistical data are unambiguously pointing out the importance of the finding in terms of the causes of the destructive damages to the parts of gas turbines. Identification of the causes of these failures could improve the reliability of those engines still within operational cycles.
