MEASUREMENT OF ELT 200 IN THE ELECTROMAGNETIC ATTENUATION CHAMBER AND ANALYSING IT UNDER IN REAL USE

Marián Mil'o – Marek Češkovič – Ján Labun – Viktor Képeši

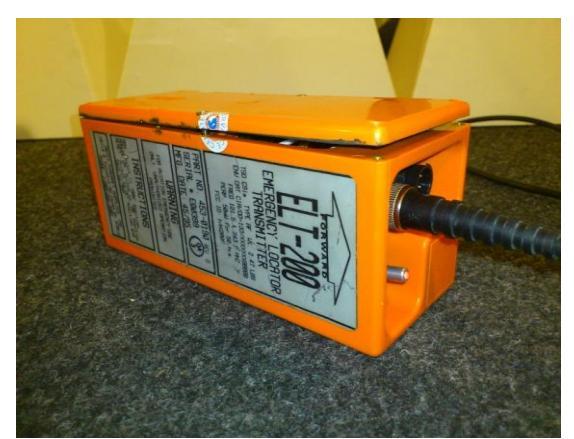
Picture. 1: view at activated emergency transmitter

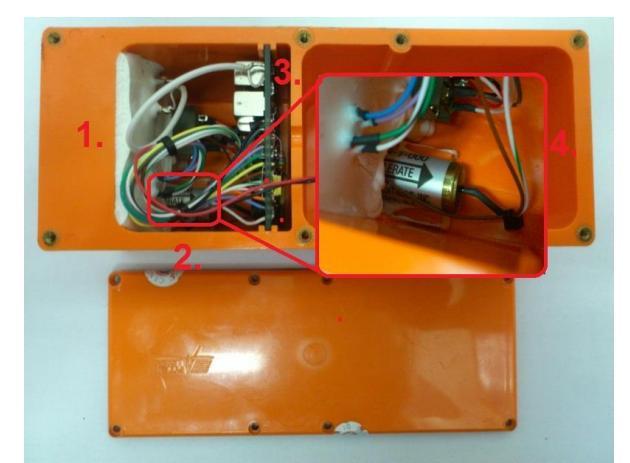
Picture. 2: 1.) Transmitter body, 2.) accelerometer (G-switch) 3.) PCB of transmitter, 4.) space for the battery pack

The *ELT 200* transmitter is available at the department of avionics at faculty of aeronautics. It is more or less the older device which after its activation works simultaneously on 2 emergency frequencies: 121,5 MHz and 243 MHz. Transmitter can be activated in two ways. The first is manually by the switch, situated in cockpit in the range of pilot hands, or the second way is to activate it automatically, by the signal of run over the G - forces from built in accelerometer, which are specified by manufacturer. The evaluation logic watches overreaching of 30g or the speed of velocity change more than 3,5 ft per second.

able to activate only by overreaching the overloading only in one axis as it is demonstrate in picture 2.

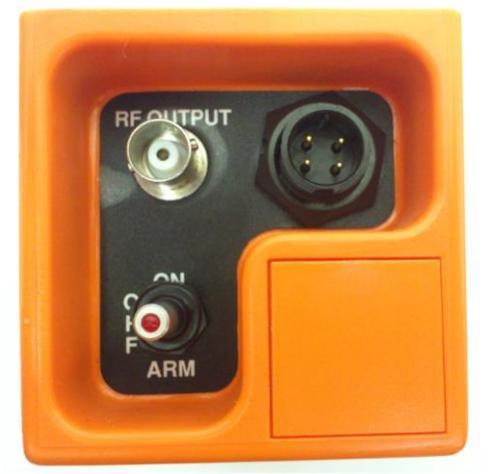
Picture 3: view at front side with connectors (for antenna and cabin switch) and main switch

Device is consisting of several elements. Except the solitary transmitter it is also the antenna, situated on the surface of each aircraft, coaxial conduction wire and control panel in cockpit. The control panel includes switch with 3 positions: ON – the device is transmitting

emergency signals, OFF – the device is non -active, ARMED – the device is ready and waiting for the overreaching the level of overloading. Its value depends on each model of ELT and its manufacturer.

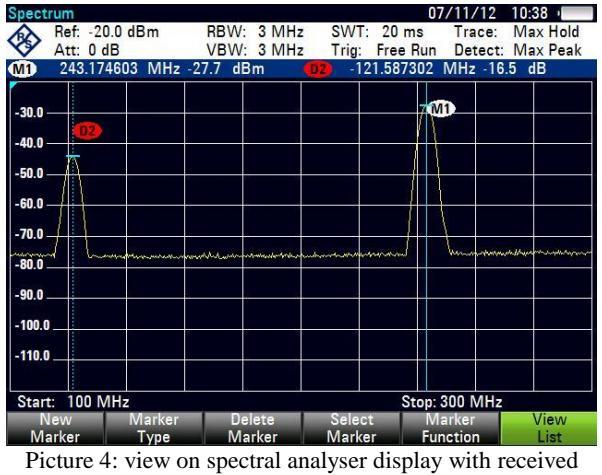
emergency signals

For the verification, if emergency transmitter is really working a spectral analyser Rohde & Schwartz FSH8 was used. That analyser was switched on in Network analyser mode and set the range of measure at value from 100 to 300 MHz. Then it was plugged - in, by the connecting the cable to the transmitting antenna. Next the chamber was closed with ELT's switch in OFF position. By the spectral analyser it was checked if it had not activated the transmitter. As a control indicator of operation of the transmitter the LED diode situated in switch is used. Subsequently that switch was switched in to the position ARMED and also checked if transmitter had not been activated. As a last step the switch was switched in to the ON position. In that moment two expected frequencies emerged on the display of spectral analyser: 121,5 and 243 MHz.

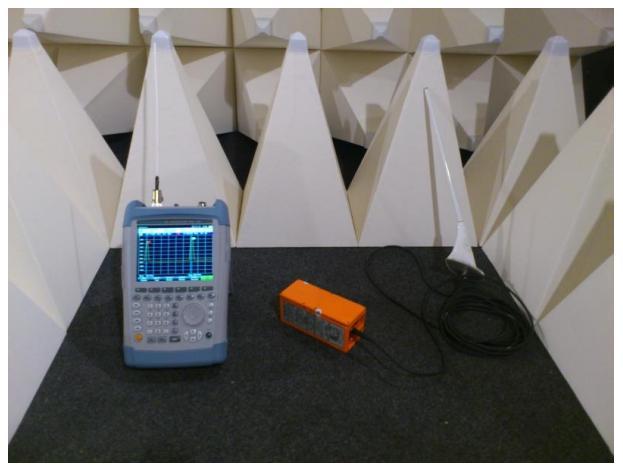
Picture 5: view on an experimental set

Steps of the overall measure are described in following lines. As a first it was necessary to make a battery pack as a power supply for the transmitter as it needs voltage of 9 Volts to be operational. The battery pack was made by the connection of 6 pieces of the type C battery, with the connector ending to sample of genuine pack.

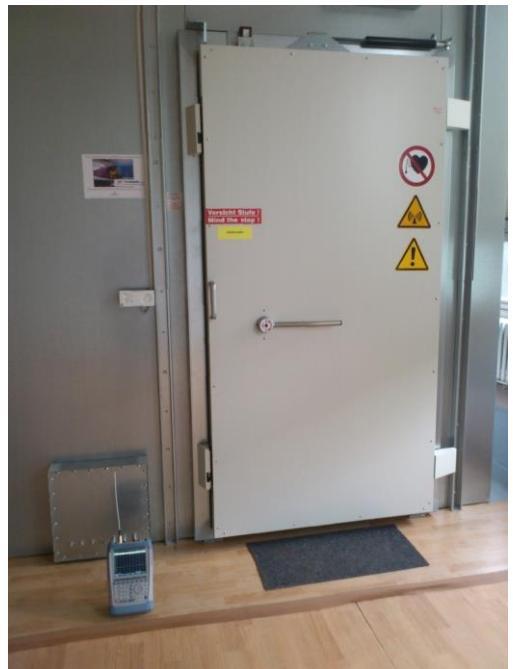
Picture 4: verifying of "radiopaque"of the signal

To verify of the fact if there is really any electromagnetic emissions behind the chamber, the other control measurement was done. During this time, the transmitter was switched on inside the chamber. The control measurement affirmed no emission of radio waves into the area out of the chamber.
