QUALITATIVE REQUIREMENTS FOR TAXIWAY "B" OF KOŠICE AIRPORT FOR USE BY AIRCRAFT TYPE B 737 800

Peter Koščák - Pavol Eliáš

4 DESCRIPTION OF THE CURRENT STATE OF TAXIWAY “B” AT THE KOŠICE AIRPORT

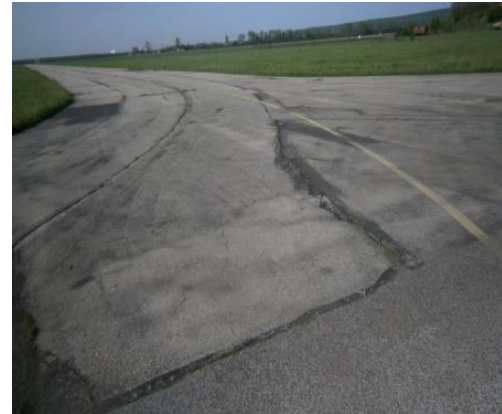
Fig. 1 Asphalt TWY “B”

thermal factors was extensive damage road surfaces. The surface is flooded large cracks, among which even in many places growing up grass and various weeds. Under the asphalt layer is about 10 cm layer of concrete of poor quality. Moreover, showing signs of inequalities, which are inadmissible in aviation? Daily axis marking and labeling whether waiting cities taxiway is significantly faded due to wear, rain and UV rays.

Since the taxiway "B" does not take more than 20 years, and due to lack of funds for it have been no reconstruction is necessary to point out to the importance of good drainage taxiway. Grating proposal is realized by the nearer the runway (see Figure 1) because this is where the sewage system, which is useful. For economic reasons, it
